SERVICE BULLETIN

Classification: BR06-011	Reference: NTB07-016	Date: March 16, 2007
-----------------------------	-------------------------	-------------------------

2004 – 2007 MAXIMA; ABS ACTIVATES WITH NORMAL BRAKING / ABS WARNING LAMP IS ON

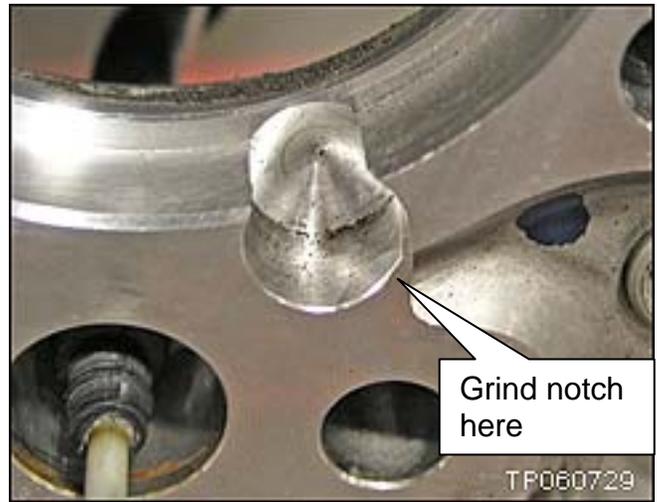
Figure 7

Before grinding

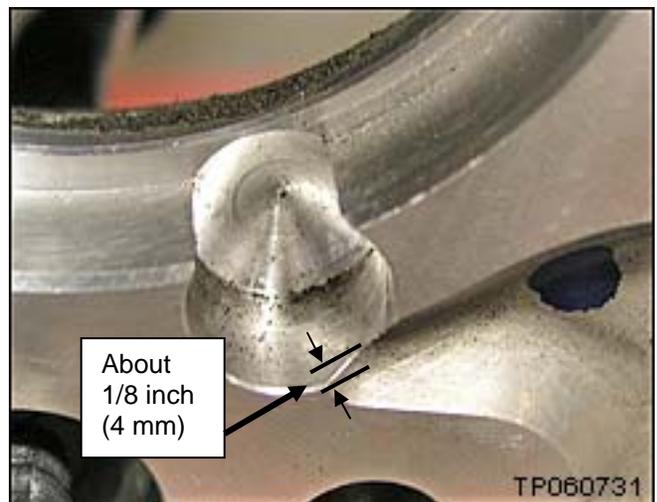
Figure 8

After grinding
