# SERVICE BULLETIN

Classification: AT09-014	Reference: NTB09-138	Date: December 18, 2009
-----------------------------	-------------------------	----------------------------

## 2009 – 2010 MAXIMA; BOOMING NOISE OR VIBRATION

**APPLIED VEHICLE:** 2009 - 2010 Maxima (A35)

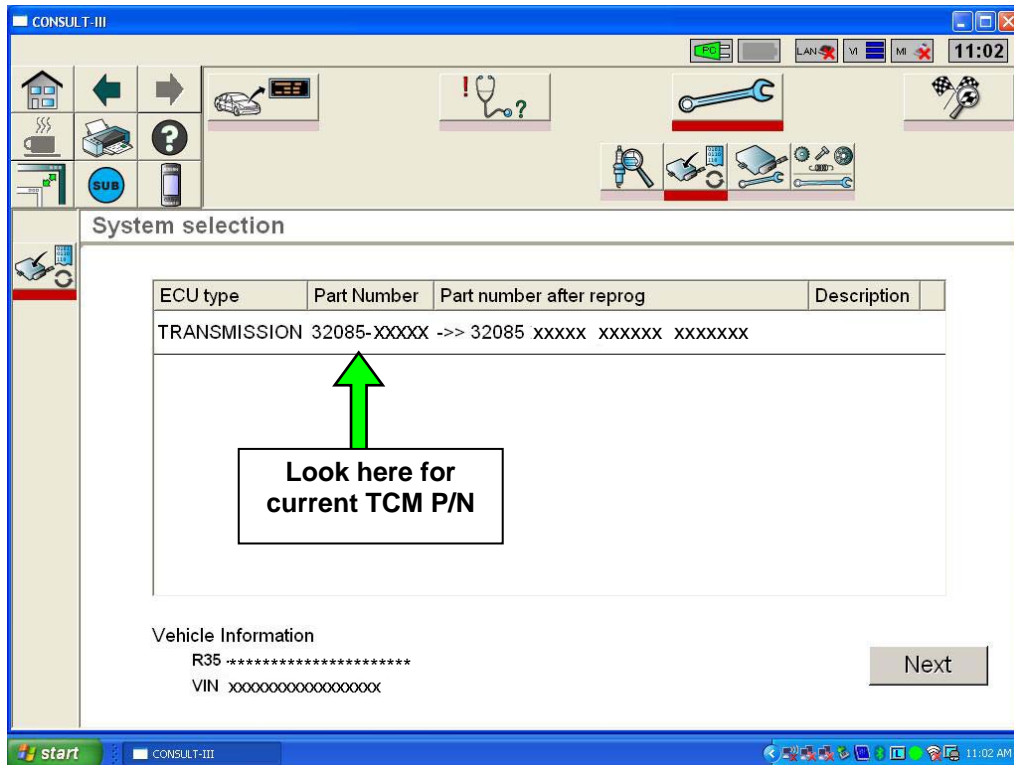
Figure 1

2. When you get to the TCM Reprogramming screen shown in Figure 1, confirm TCM reprogramming applies as follows.
  - A. On your C-III screen, look at the **Part Number (P/N)** column (see Figure 1).
    - Write down the P/N on the Repair Order.

- B. Compare the P/N you wrote down to the numbers in the **Current TCM P/N** column in **Table A** below.
  - If there is a match this bulletin applies. Continue with the reprogramming procedure.

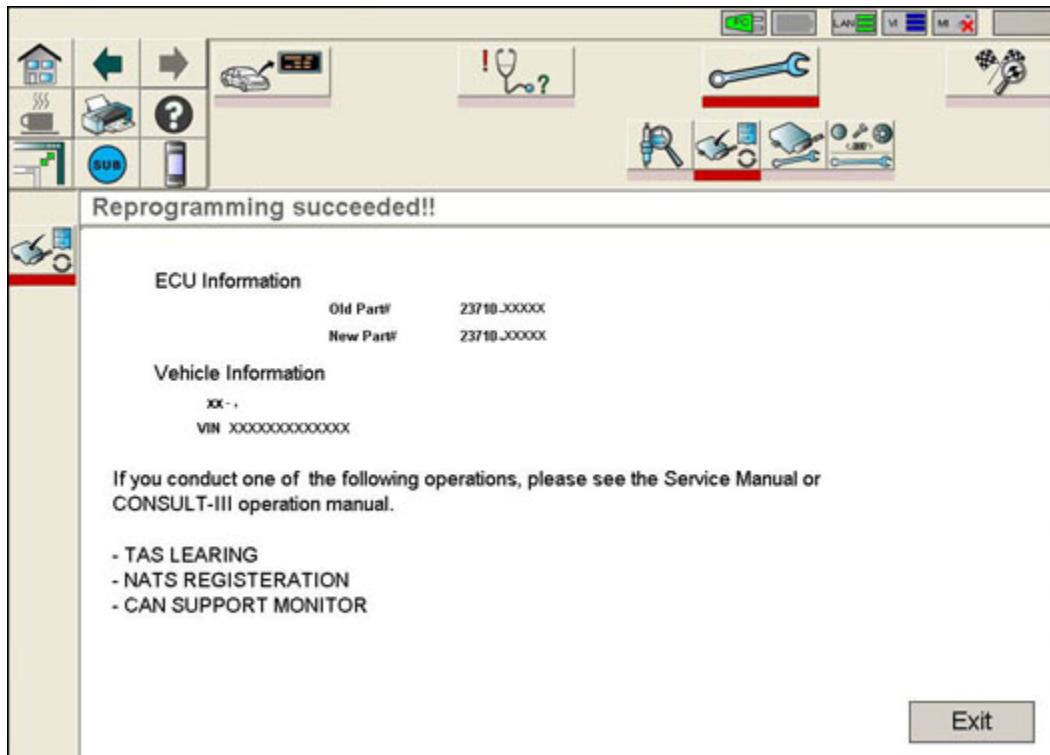
3. If this bulletin applies and you have performed TCM reprogramming, the screen in Figure 2 displays when reprogramming is complete.

**Print this screen and attach it to the Repair Order for Warranty documentation.**
