## SERVICE BULLETIN

| EL15-002f | NTB15-009f | August 1, 2017 |

### NAVIGATION SYMPTOMS WHEN SD CARD IS MISSING OR WRONG CARD INSTALLED

**APPLIED VEHICLES:** 2015-2017 Murano (Z52)  
2016 Murano Hybrid (Z52)  
2016-2017 LEAF (ZE0)  
2016-2017 Maxima (A36)  
2017 GT-R (R35)

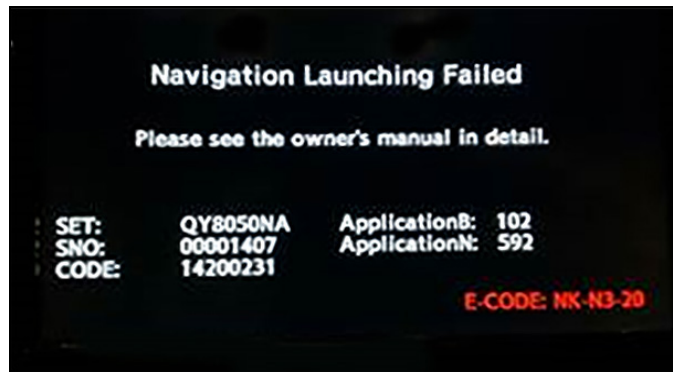
**If the wrong SD Map Card has been inserted into the Navi/audio unit:**

- A “Navigation Launching Failed” screen will be shown (Figure 1).

- **Mixed up with other SD Map Cards**
  - Continue to insert individual SD Map Cards until one can be found that the error message in Figure 1 is not displayed.

- Check the “Unit code” (page 3) and then look up the correct SD card part number with **SD Card Numbers by Unit Code** starting on page 5.
