## Front Heated Oxygen Sensor (Front HO2S) (Right bank) (DTC: 0503) (Cont'd)

## COMPONENT INSPECTION

## Front heated oxygen sensor heater

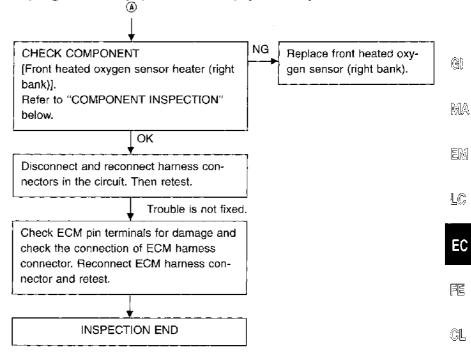
Check resistance between terminals 3 and 1. Resistance: 2.3 - 4.3 $\Omega$  at 25°C (77°F)

Check continuity between terminals ② and  $\mathring{\textcircled{1}}$ , ③ and ②.

Continuity should not exist.

If NG, replace the front heated oxygen sensor.
